Name of Author: Mark D'Andrea

Title of Thesis: Behaviour and Rehabilitation of Distortion-Induced Fatigue Cracks in Bridge Girders

Behaviour and Rehabilitation of Distortion-Induced Fatigue Cracks in Bridge Girders

Fall 2001

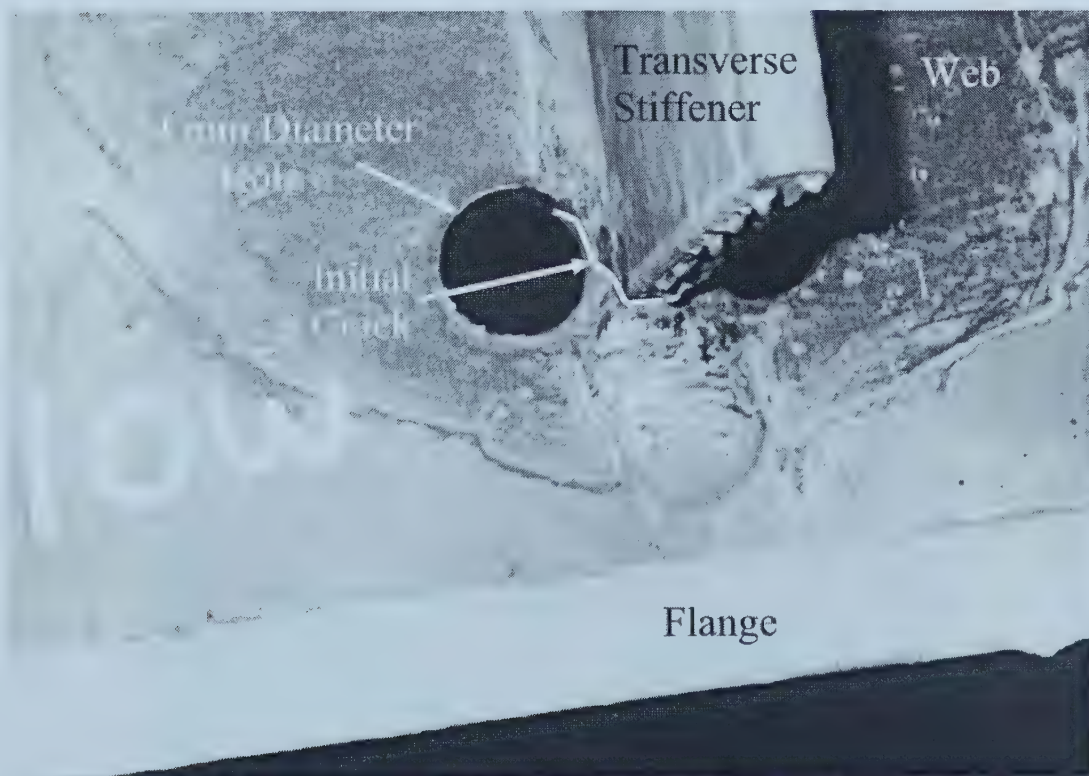
Figure 4-2 Initial Crack and Stop Holes on West Face of Joint 10, Specimen 1

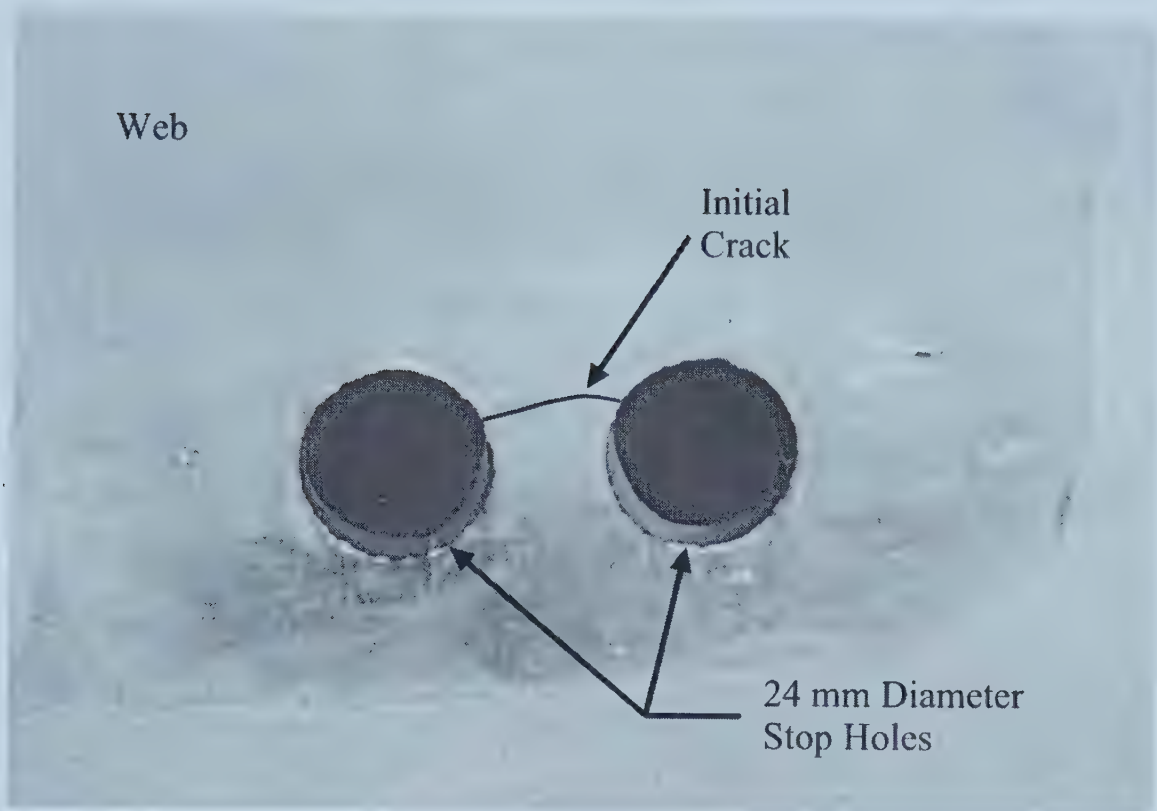
Figure 4-3 Initial Crack and Stop Holes on East Face of Joint 10, Specimen 1

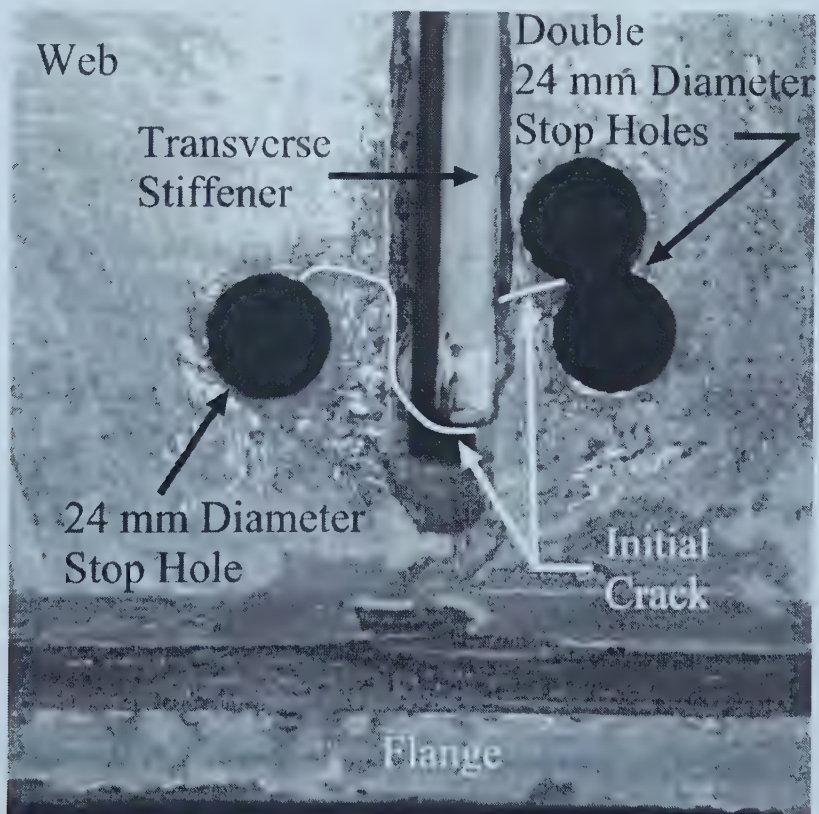
Figure 4-4 Initial Crack and Stop Holes on West Face of Joint 12, Specimen 2

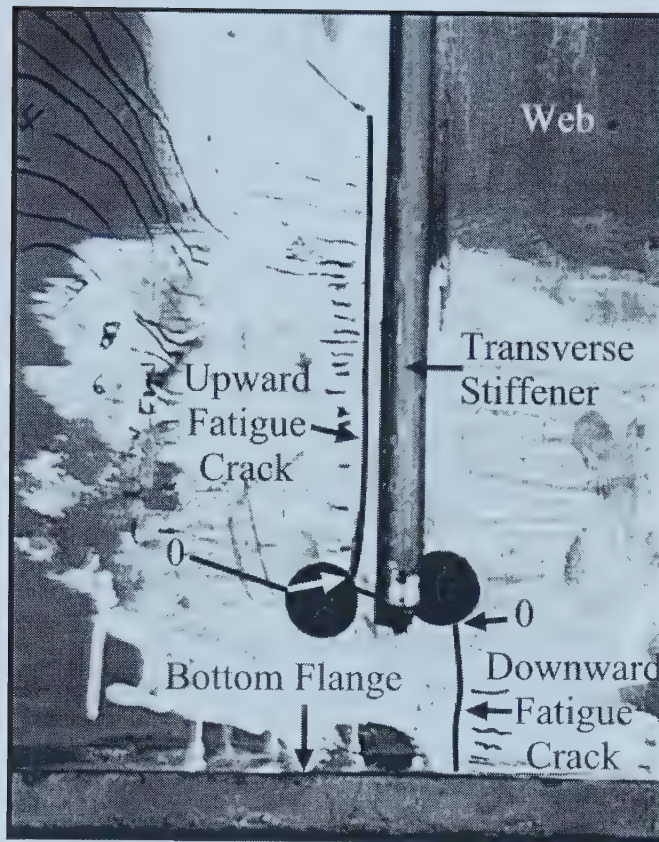
Figure 4-11 Fatigue Crack on West Face of Joint 12, Specimen 1

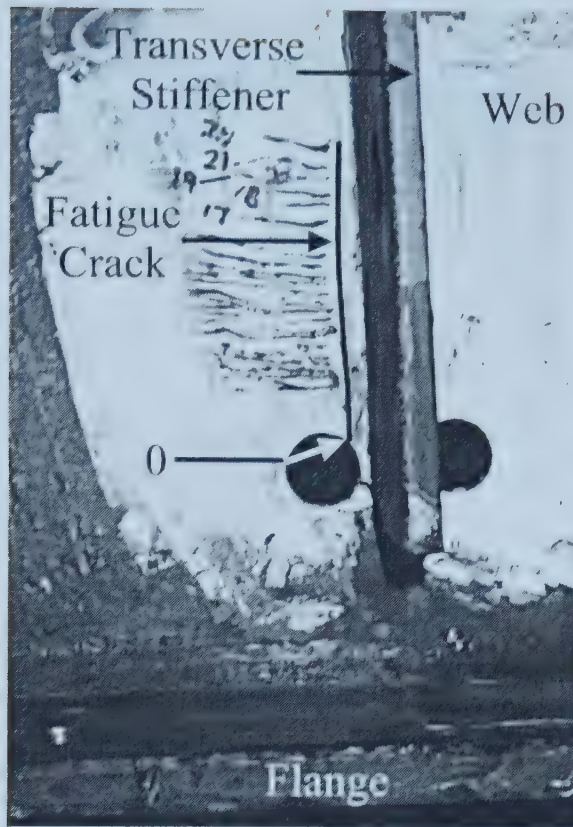
Figure 4-13 Fatigue Crack on West Face of Joint 10, Specimen 2

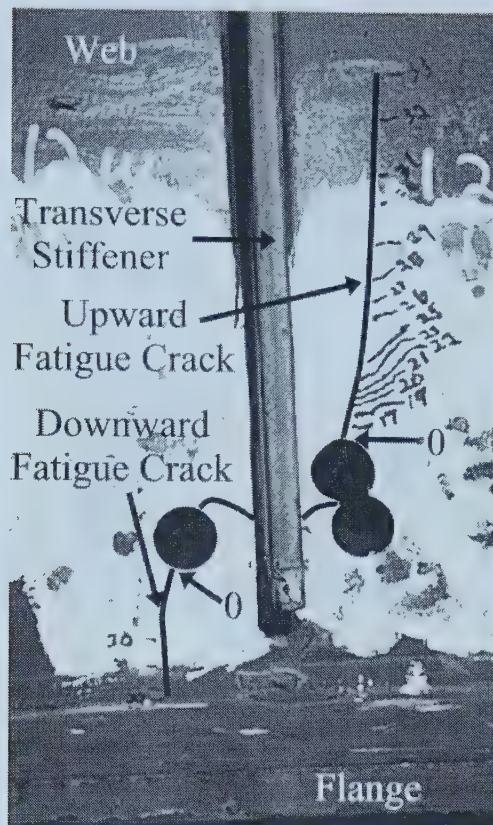
Figure 4-15 Fatigue Crack on West Face of Joint 12, Specimen 2

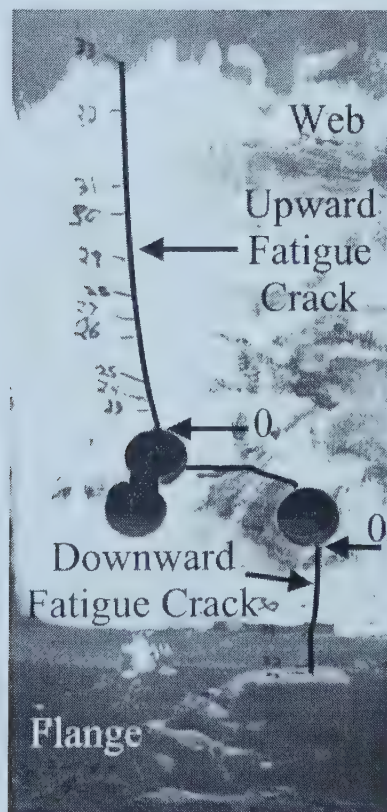
Figure 4-16 Fatigue Crack on East Face of Joint 12, Specimen 2

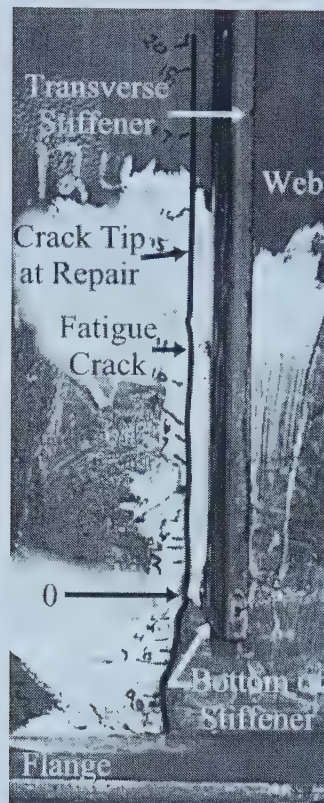
Figure 4-17 Fatigue Crack on West Face of Joint 12, Specimen 3

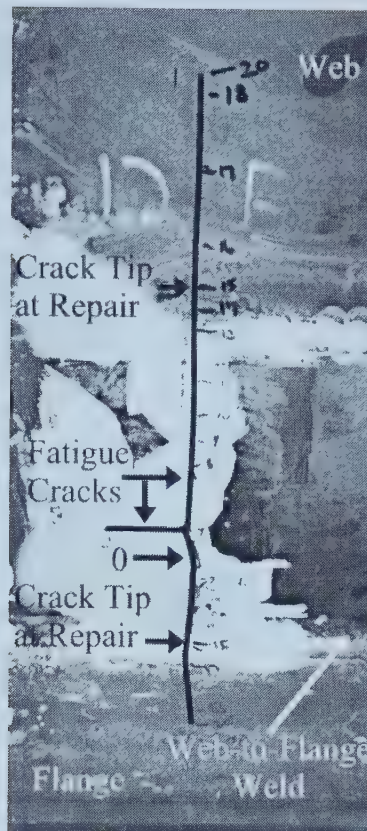
Figure 4-19 Fatigue Crack on East Face of Joint 12, Specimen 3

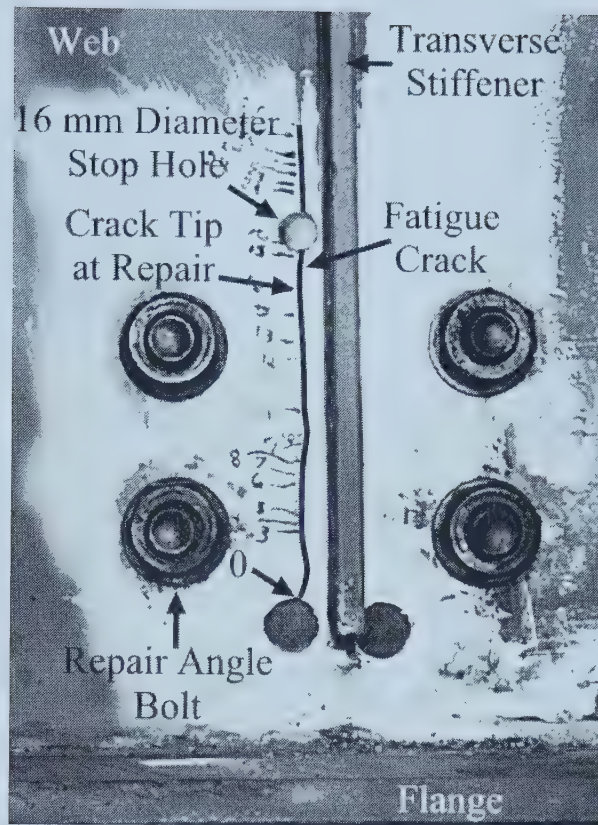
Figure 4-21 Fatigue Crack on East Face of Joint 11, Specimen 4

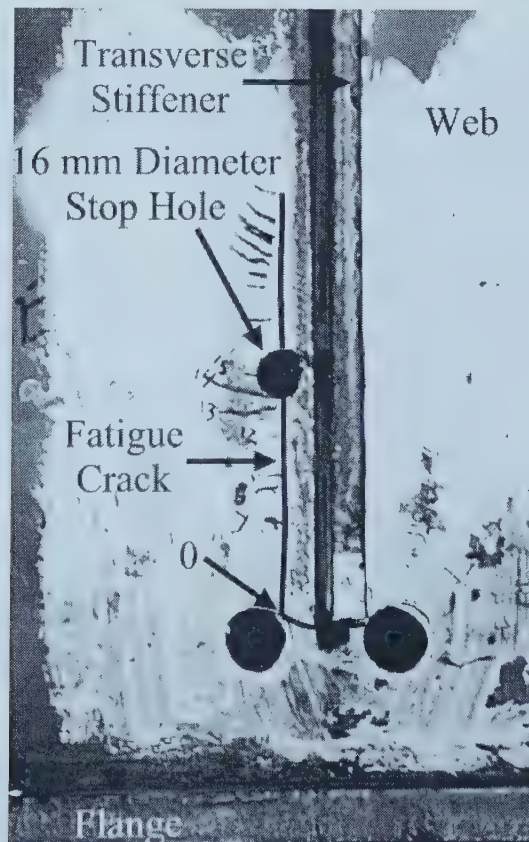
Figure 4-22 Fatigue Crack on East Face of Joint 13, Specimen 4

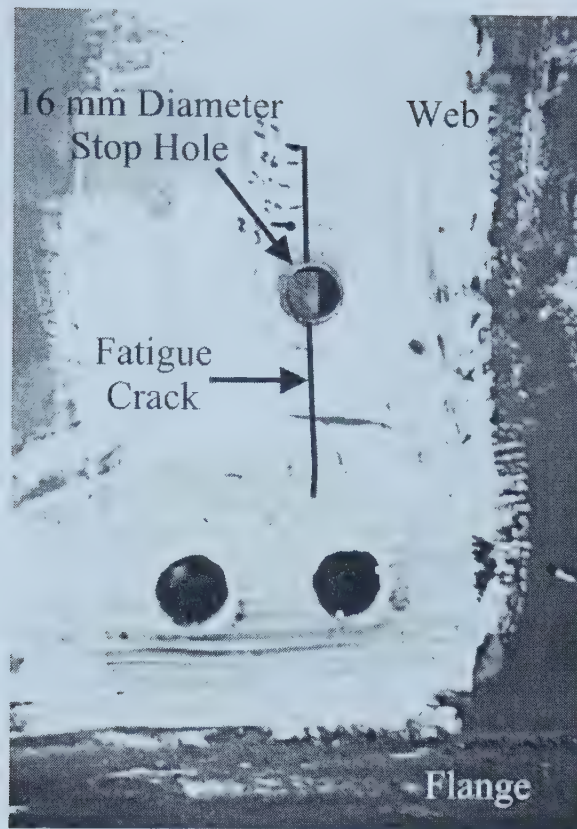
Figure 4–29 Fatigue Crack on West Face of Joint 13, Specimen 4

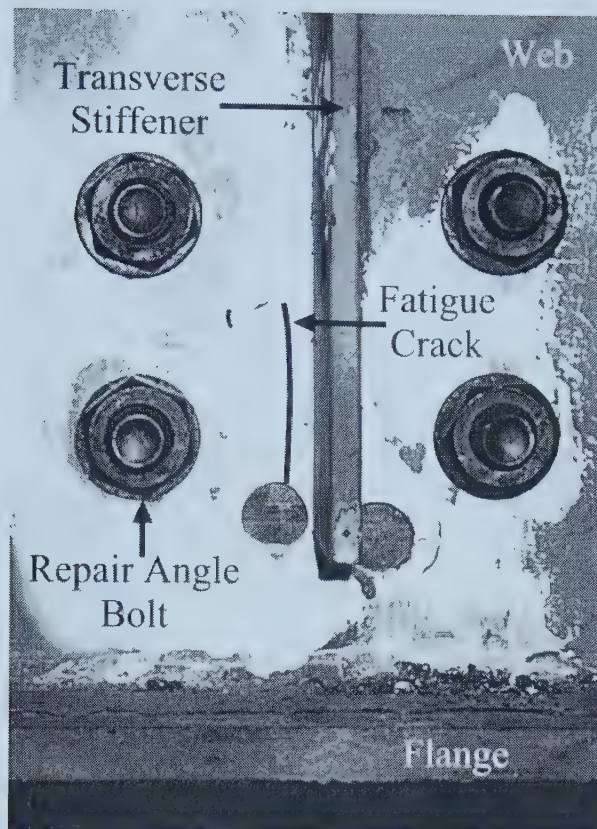
Figure 4-33 Fatigue Crack on East Face of Joint 11, Specimen 5

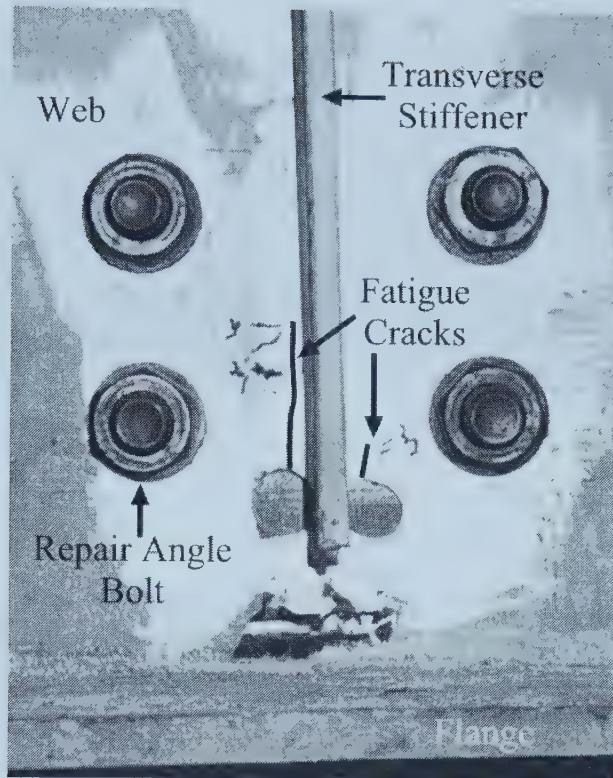
Figure 4-35 Fatigue Crack on West Face of Joint 12, Specimen 5

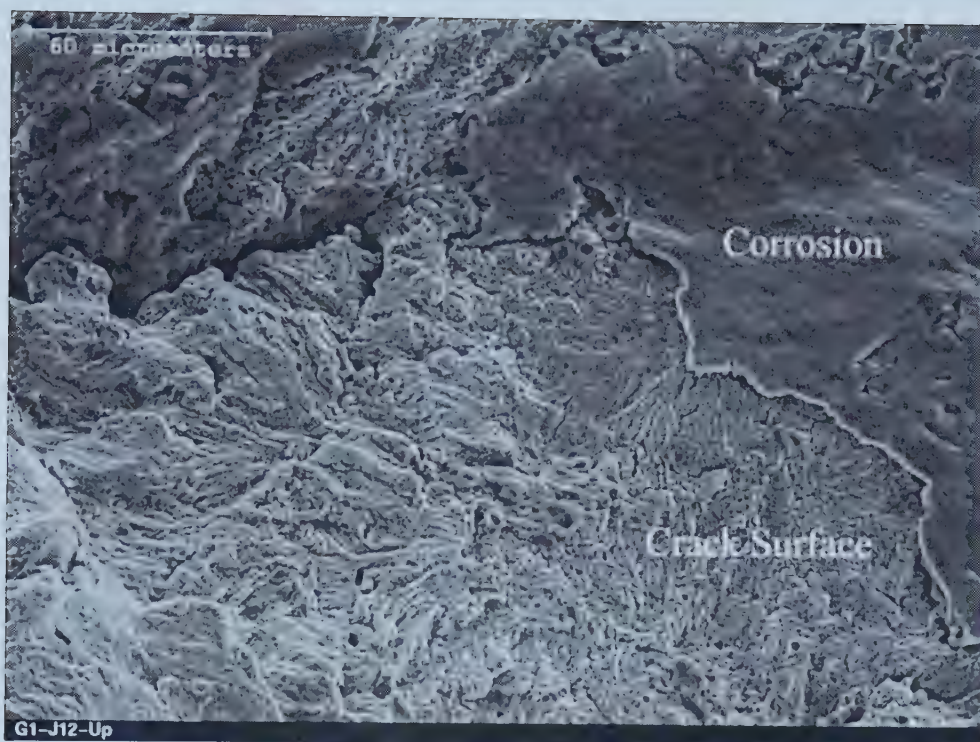
Figure 4-38 Corrosion of Upward Fatigue Crack Surface at Joint 12, Specimen 1

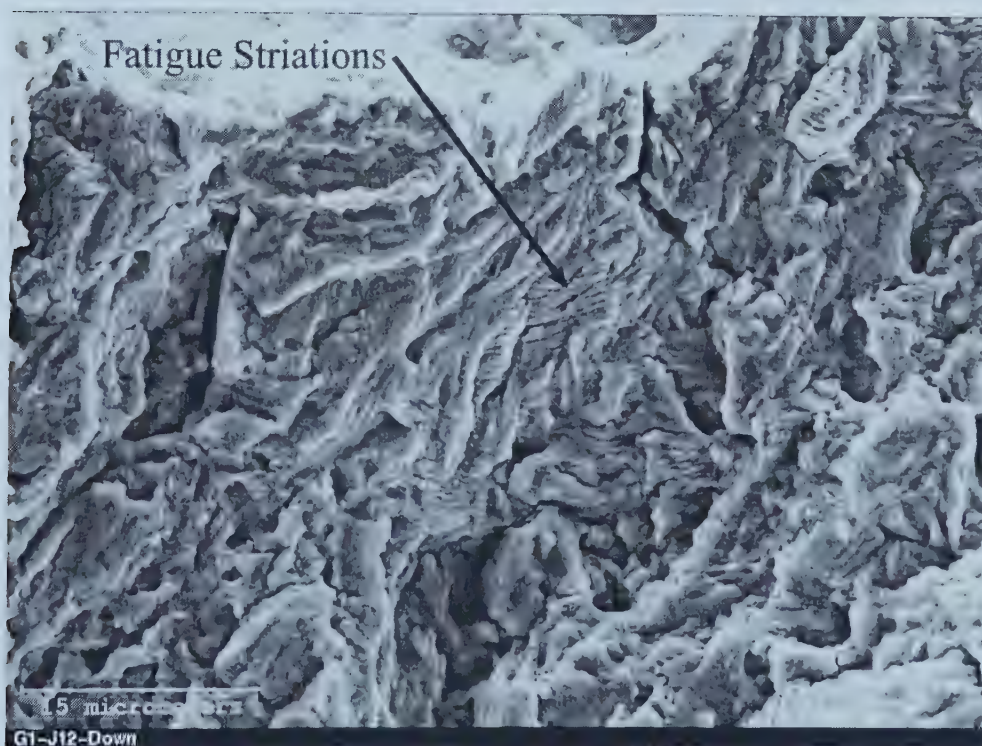
Figure 4-39 Fatigue Striations on Downward Fatigue Crack Surface at Joint 12, Specimen 1

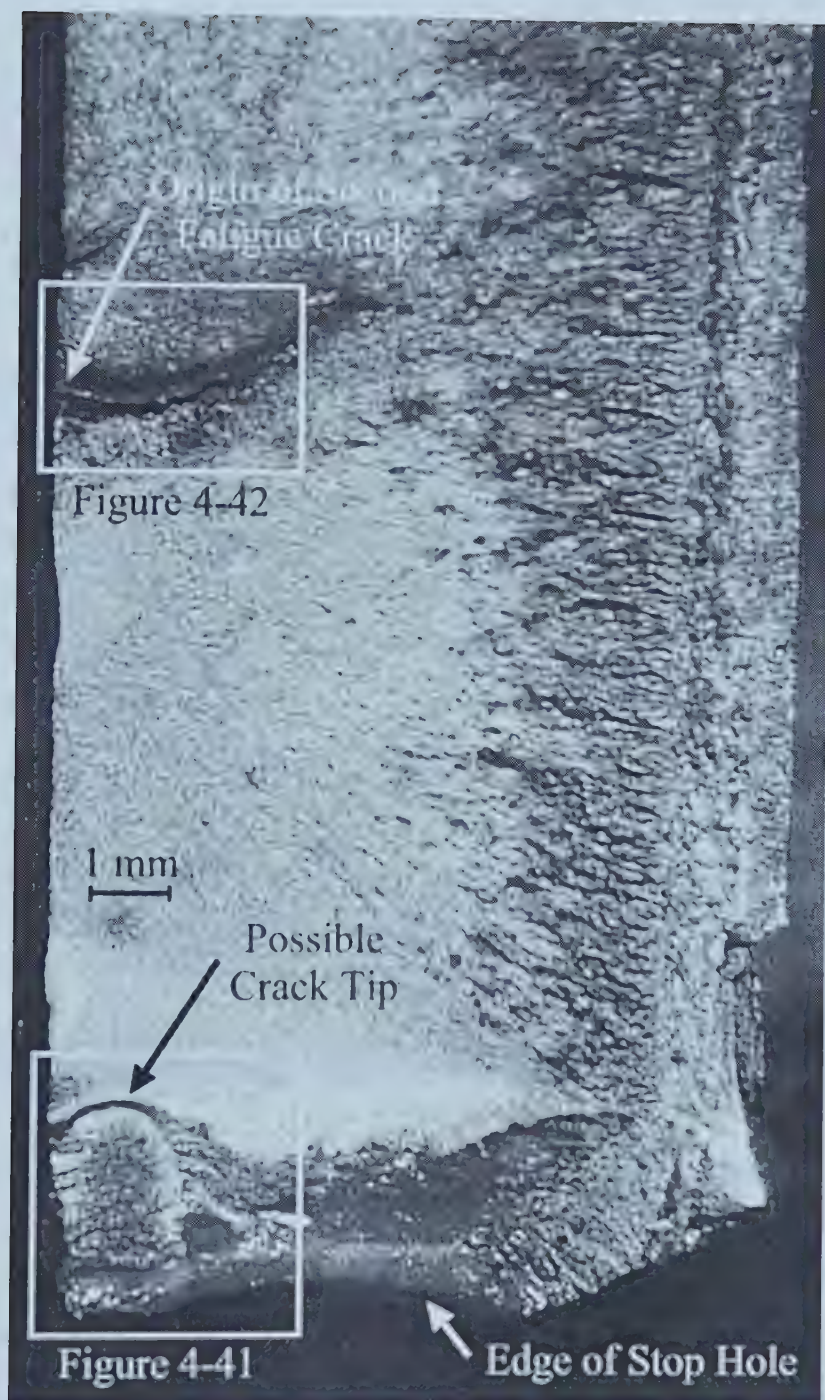
Figure 4-40 Upward Fatigue Crack Surface at Joint 10, Specimen 2

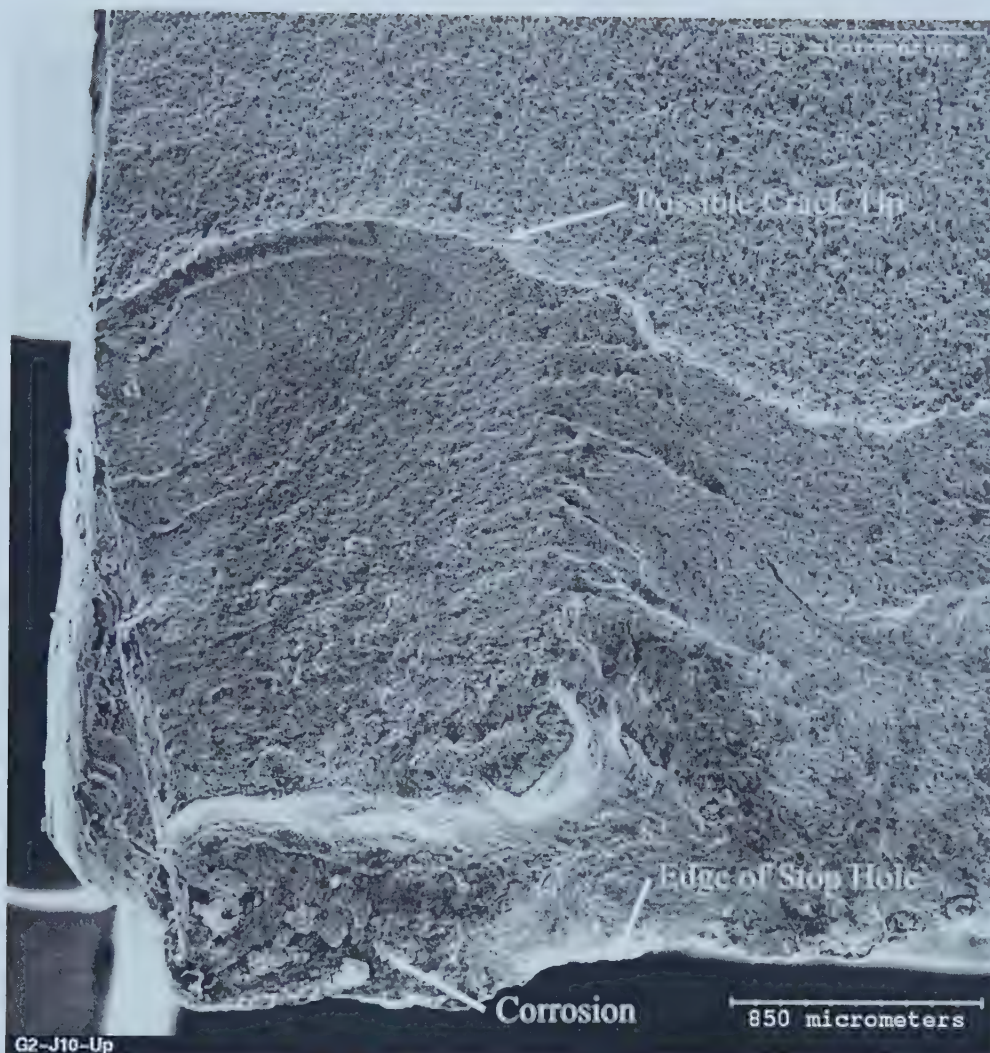
Figure 4-41 Upward Fatigue Crack Surface at Edge of Stop Hole at Joint 10, Specimen 2

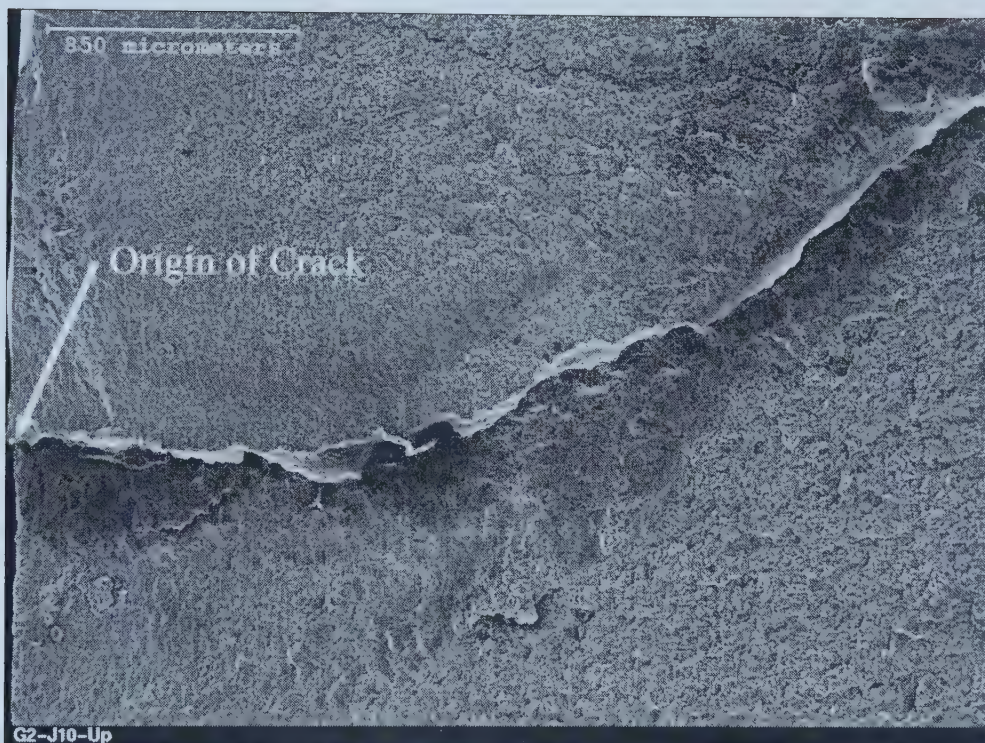
Figure 4-42 Upward Fatigue Crack Surface 11 mm from Edge of Stop Hole at Joint 10, Specimen 2
